Reconstruction is Beginning

House of Hope

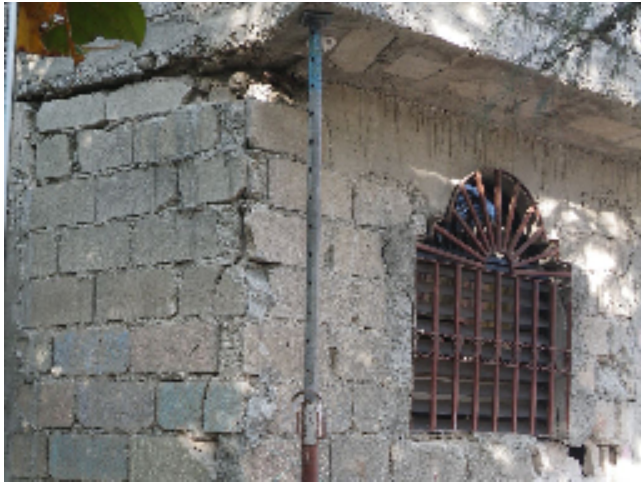
Photo of front corner of House of Hope showing block wall knocked out of place. A number of interior and exterior walls received similar damage.

House of Hope received serious, but repairable damage. Following is the report from our Haitian architect Chetlin-

“The building was partially cracked under the strikes of the devastating earthquake, so it needs to be reinforced. Some of the columns and walls are cracked. Due to this situation, all the columns have to be reinforced and the cracked wall have to be replaced in order to guarantee the safety of the users.”

The total cost for this portion of repairs will be \$10,957. We have been blessed with donations to cover this part of the repairs. After structural repairs are complete, work teams will be needed to patch “surface” cracks and repaint the interior of the building. Structural repairs will include wrapping damaged columns in a 1/8 inch steel casing, adding additional steel support posts next to undamaged columns, and reinforcing concrete block walls to prevent cracking.

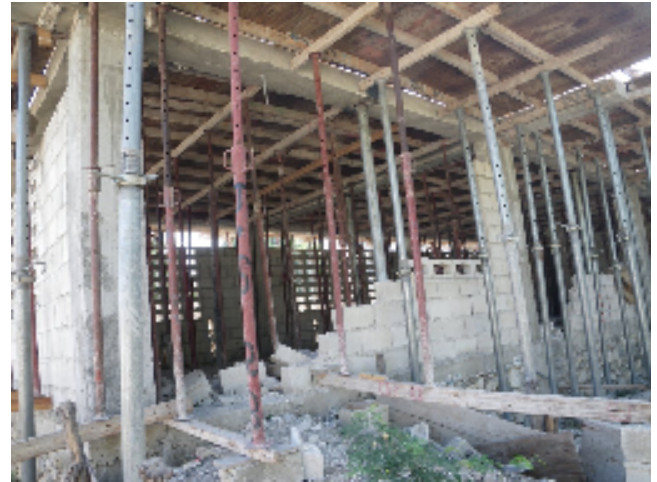
A view of one of the West walls of Patti’s School knocked down by the quake. The walls will be rebuilt to be earthquake resistant.

The school walls did not fare as well as the school’s columns and beams. The wall along the West side of the school collapsed. When the quake struck, the walls were only partially complete and not fully supported.
